STRUCTURAL PERFORMANCE TEST REPORT

TUSCAN MANUFACTURING, LP

PRODUCT: Colonial & Classic Porch Post

Report No: 70255.03-119-16
Report Date: 06/27/07
Revision 1: 07/11/07

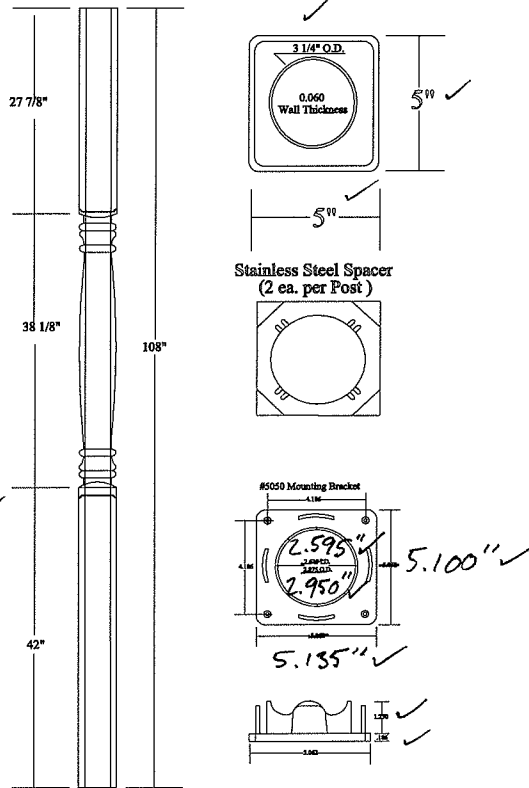
Tuscan Manufacturing, LP
Colonial Porch Post

4"x 4"x 108"

5"x 5"x 108"

Test Samples: All test samples were provided by Tuscan Manufacturing for testing. The *Classic* compression samples measured 104" in length and the *Colonial* samples measured 108". Each *Classic* sample was comprised of an aluminum reinforcing member (tube) inside of a vinyl porch post. The aluminum tube had a 0.060" wall thickness and an outside diameter of 3.25" for the 4.5 x 4.5 porch posts and the 4 x 4 *Colonial* had a 0.060" wall thickness and an outside diameter of 2.5" and the 5 x 5 *Colonial* had a 0.060" wall thickness with an outside diameter of 3.25". The 4.5 x 4.5 posts had stainless steel plate spacers 22" from the top and 40" from the bottom. The 4 x 4 and 5 x 5 posts had stainless steel plate spacers 26" from the top and 41" from the bottom. See drawings in Appendix A and photographs in Appendix B for additional description.

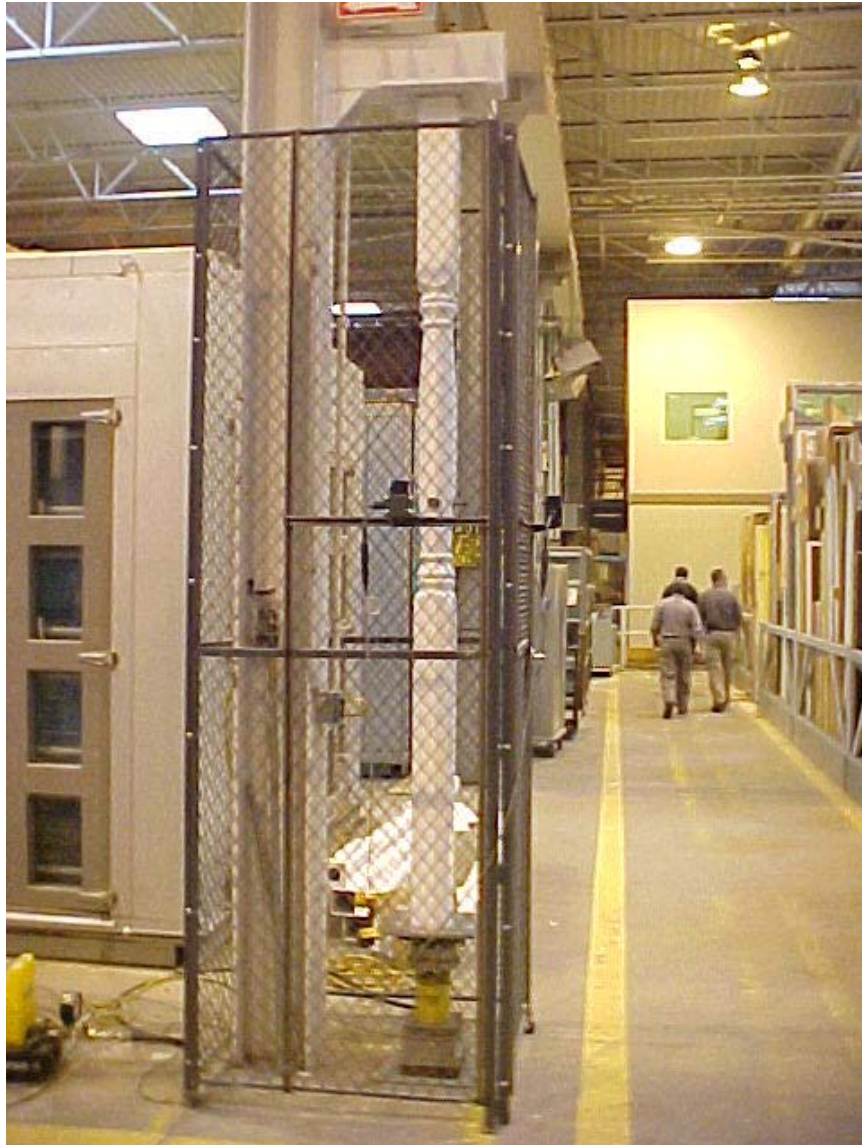
Photo No. 1
Axial Compression Load Test Set-Up

Axial Compression Load Test: The test fixture consisted of a flat steel support attached to a rigid steel column at the top. The bottom consisted of a hydraulic jack positioned on a leveling fixture, fitted with flat steel bearing plate and a 50,000 pound capacity load cell. Test duration, load, and deflection were recorded electronically throughout the test.

Axial Compression Load Test: The posts were installed into the compression fixture with no physical connections between the post and fixture. The compression fixture was plumbed using a "PLS-5" laser plumbing device, and the column was leveled with a 78" level, while applying a minimal preload to hold the specimen in place. Two electronic linear displacement transducers were positioned at the midpoints of two adjacent sides of the columns, to measure lateral displacements about the x- and y-axis of the column.

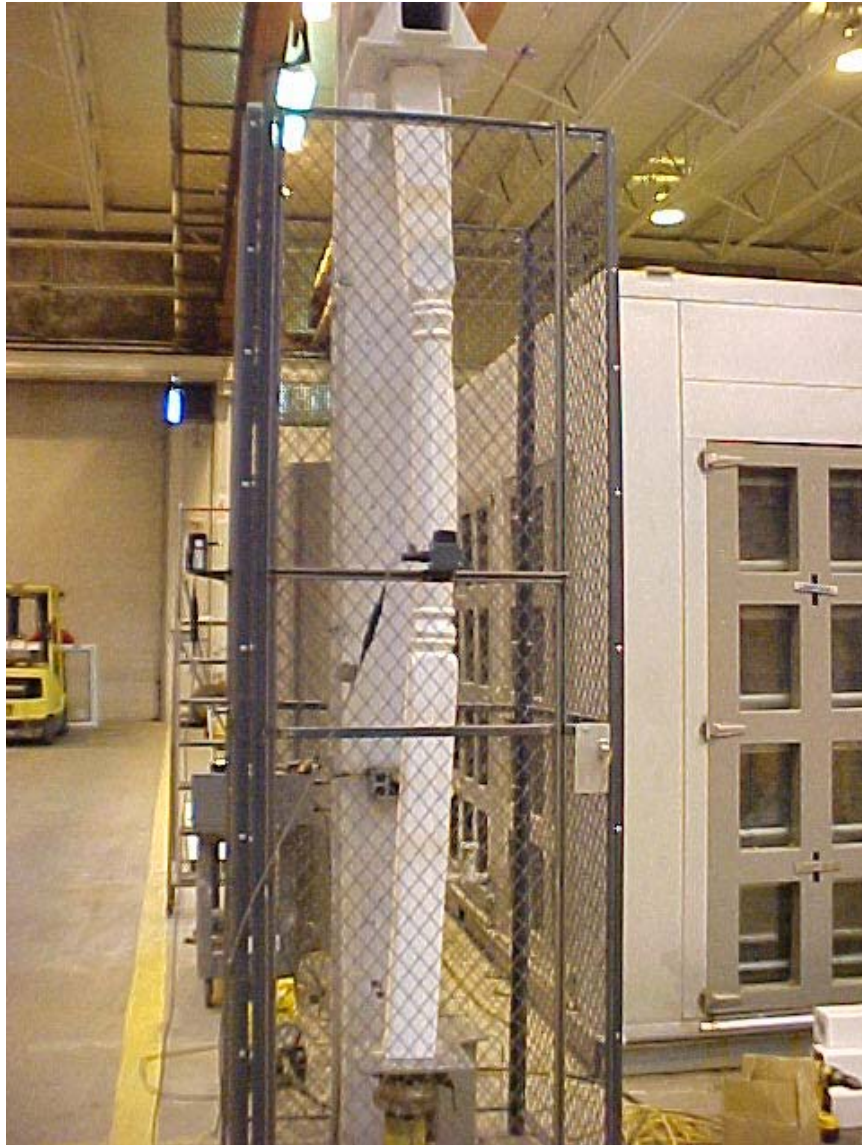
Photo No. 2
Axial Compression Load Test in Progress

Axial Compression Load Test: Each test began with a small initial load and continued a uniform load increase until failure. Load, lateral displacements and time were recorded. The ultimate load and mode of failure were recorded for each test. Three tests were performed on each design.

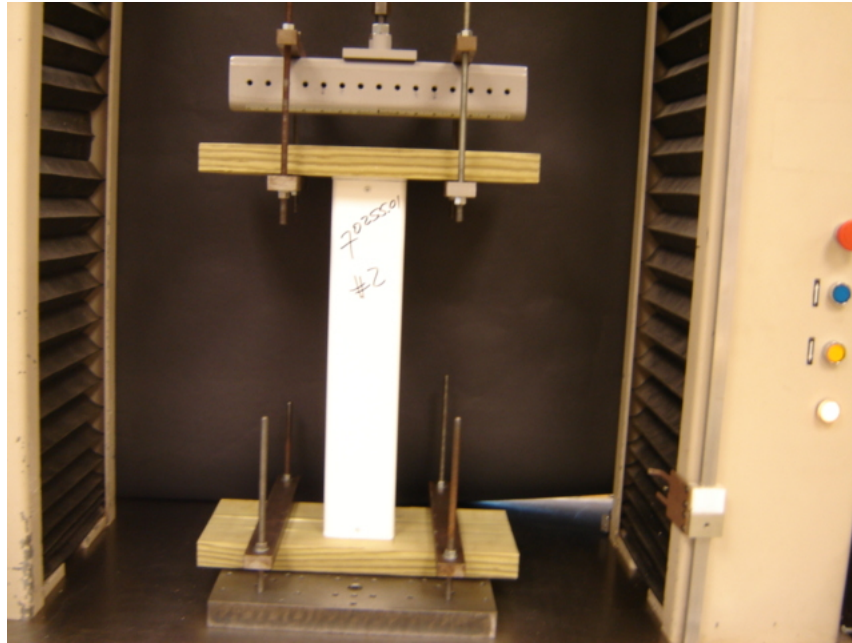
Photo No. 3
Uplift Resistance Test Setup

Uplift Load Test: The specimens were tested to ultimate capacity in tension utilizing a SATEC Model 50UD universal test machine.

Uplift Load Test: The testing machine was fitted with pressure treated Southern Yellow Pine (SYP) wood boards at the top and bottom to accommodate anchorage of the column brackets. The end bracket for the 4 x 4 post was secured to the wood board with four (4) #14 by 1-1/2" flathead stainless steel screws. The post was then attached to each bracket with two (2) #10 by 2-3/8" pan-head stainless steel screws. The end bracket for the 5 x 5 post was secured to the wood board with four (4) #14 by 1-1/2" stainless steel screws. The post was then attached to each bracket with two (2) #10 by 2-3/8" pan-head stainless steel screws. Tests were run at a cross-head speed of 0.05 in./min. and all tests were conducted at lab ambient temperature (68°F ±4°F). Reference photographs in Appendix B for test setups.

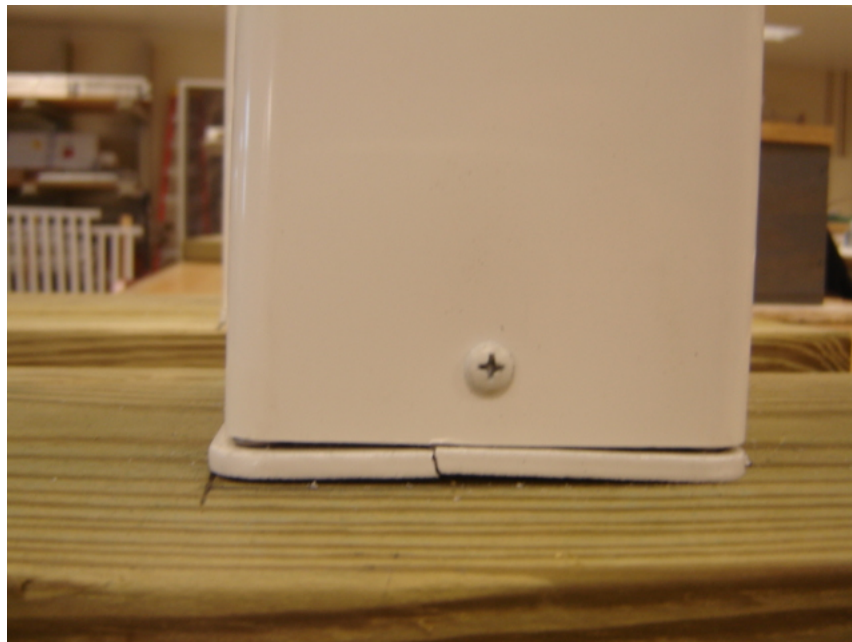
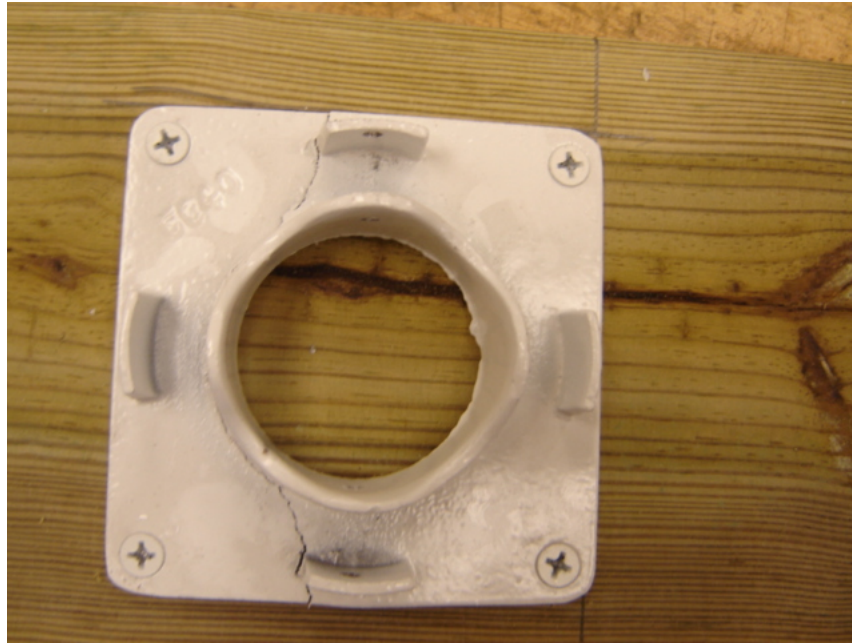
Photo No. 4
Uplift Resistance Tests - Plate Failure

Photo No. 5
Uplift Resistance Tests - Plate Failure

Specimen No.	Ultimate Load (lb)	Percent Deviation From Average	Failure Mode
1	1632	0.3%	Plate Cracked
2	1648	0.7%	Plate Cracked
3	1631	0.4%	Plate Cracked
Average	1637

Specimen No.	Ultimate Load (lb)	Percent Deviation From Average	Failure Mode
1	1854	0%	Plate Cracked
2	1945	5%	Plate Cracked
3	1762	5%	Plate Cracked
Average	1854

See photographs in Appendix B for mode of failure.

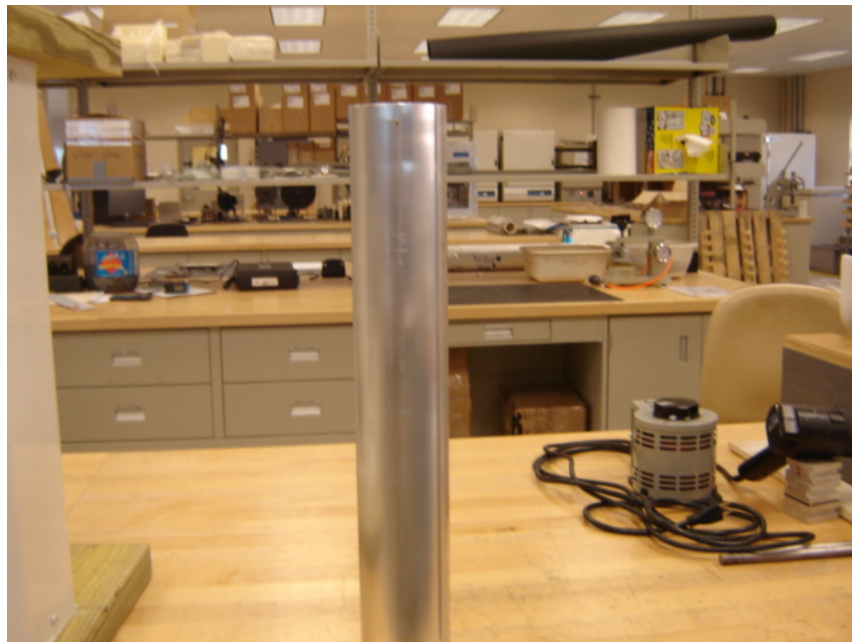
Photo No. 6
Uplift Resistance Tests - Circular Tubing in Center of Column
